# Information Bulletin

## Response and Mitigation of Overturned MC-331 Specification Tank Trucks

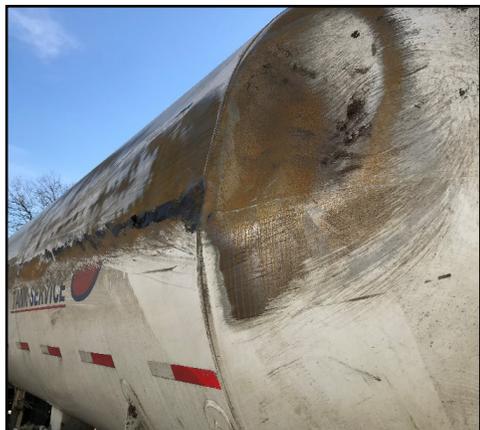
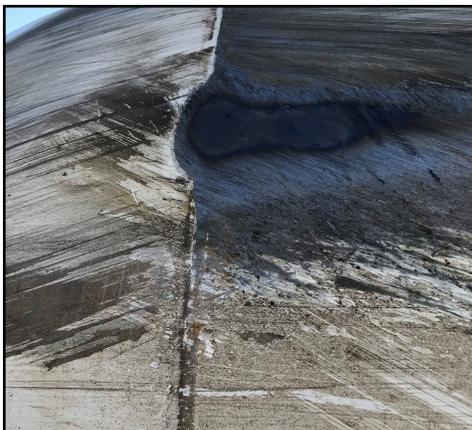
An MC-331 exhibiting any of the following damage should be left in place and off-loaded.<sup>iv, v</sup>:

- Dents that are at least 1” in depth in general or 0.5” depth for dents that include a weld.
- Locations where it appears that metal thickness has been diminished, thinned, or stretched.
- Gouges, especially if they cross a weld.
- Areas of steel that have been affected by heat due to friction or flame impingement
- Any cracks
- A leak of product

Once a complete damage assessment has been performed and a decision to up right has been made, coordinate with the tow truck/crane operator to pause once the tank is off the ground so that the qualified individual can assess the side that was not visible while the tank was on the ground. If suspect damage is found, the re-righting process should stop, and the tank should be laid back down.
