Report of the Fire, Building and Life Safety Code Applicability at the Riverview IRA

Prepared by:
New York State
Department of State
Office of Fire Prevention and Control

June 4, 2009

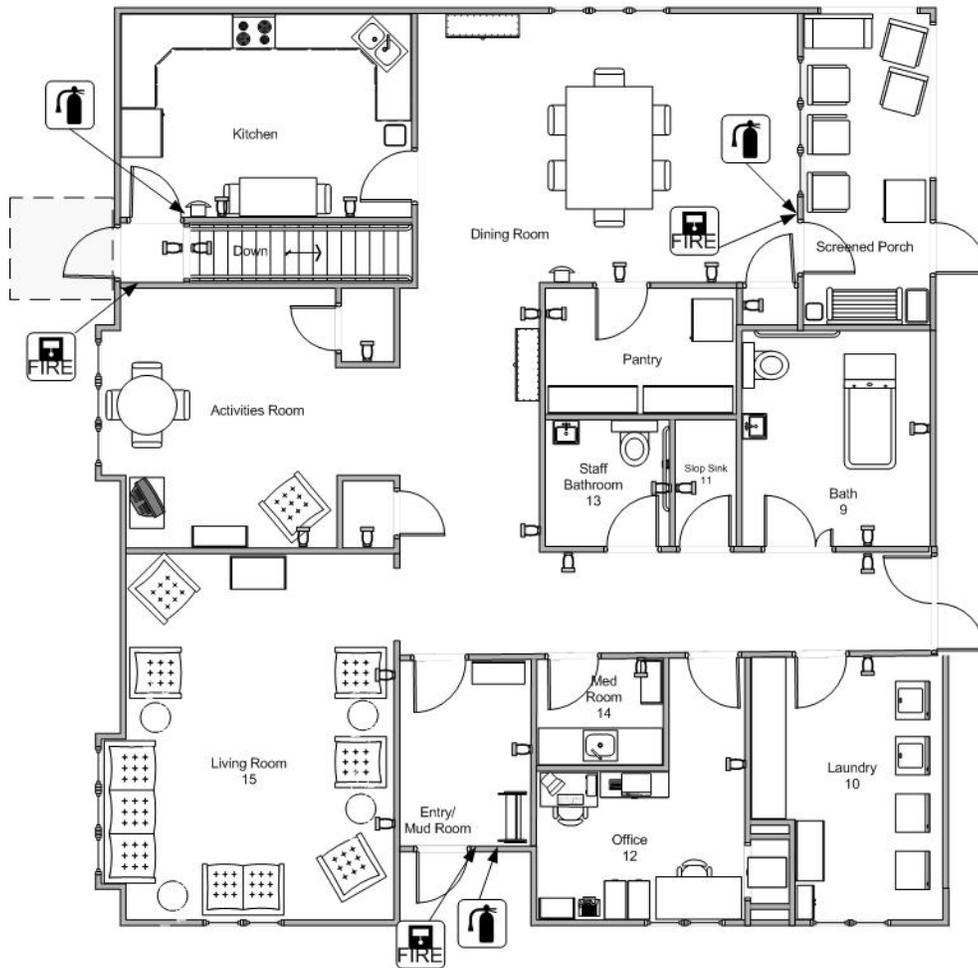
North End of Building
Drawing 2 of 3

During the post event inspection by OFPC, obstructions were noted within the facility:

At the time of this report, OFPC cannot determine through staff interviews, whether these objects hindered egress and/or evacuation of residents at the time of the fire. Nevertheless, the obstructions were violations of the *Property Maintenance Code of New York State*.¹⁷

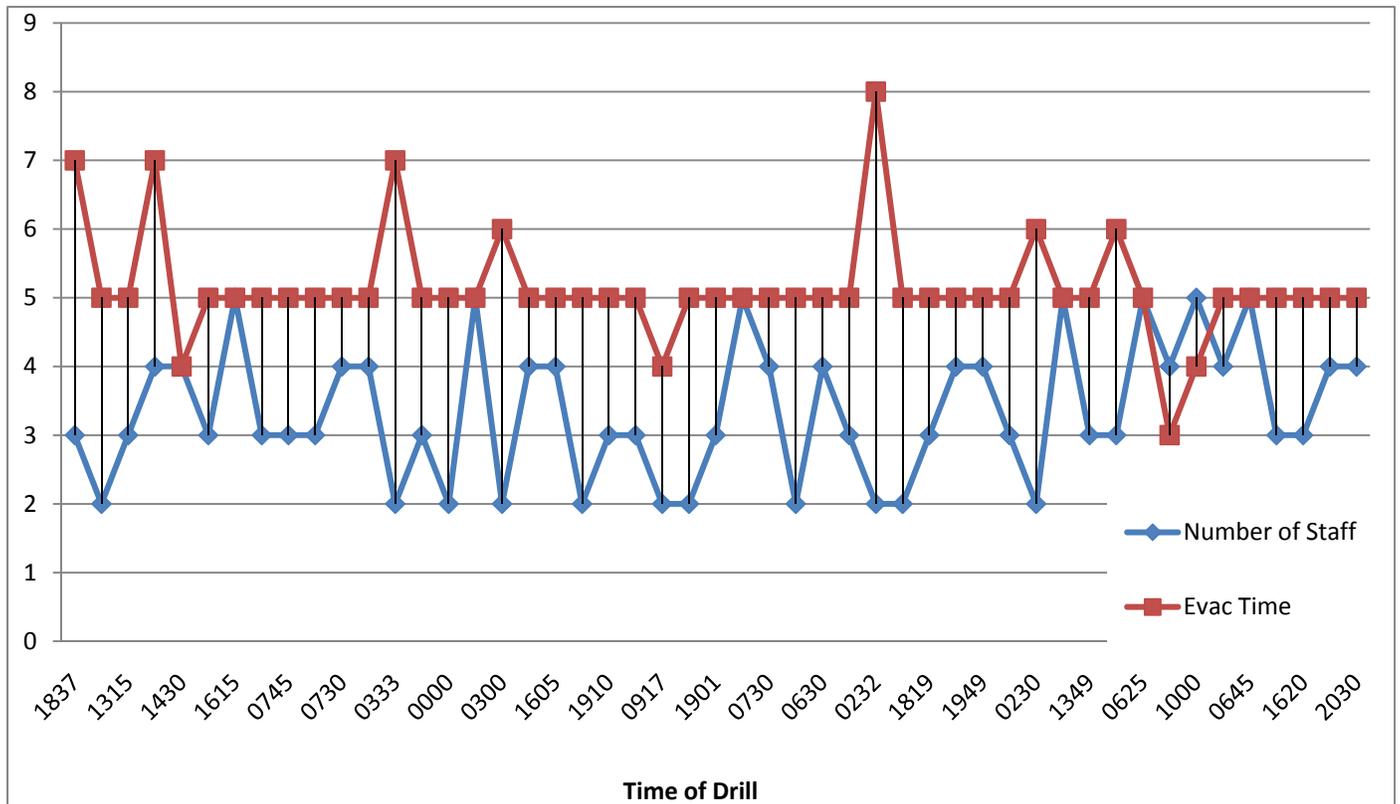
Time of Recorded for Total Evacuation vs. Number of Staff Participating

It is noted that on the morning of the fire, the fire alarm activated at 0525 hrs. and the assistant fire chief arrived on the scene approximately eight minutes after alarm activation²², yet at that time, the evacuation had not been completed. There were no residents outside the structure or assembled at the designated safe area. It was only with the assistant fire chiefs help that the first residents were removed from the structure to the designated safe area.
