FOLLOW UP: ALERT 0903241 - MANIFOLD FAILURE TEST REPORT

Snap-tite Hose, Inc.

Product: MS40M25N

Reason for Return: Catastrophic failure of the manifold

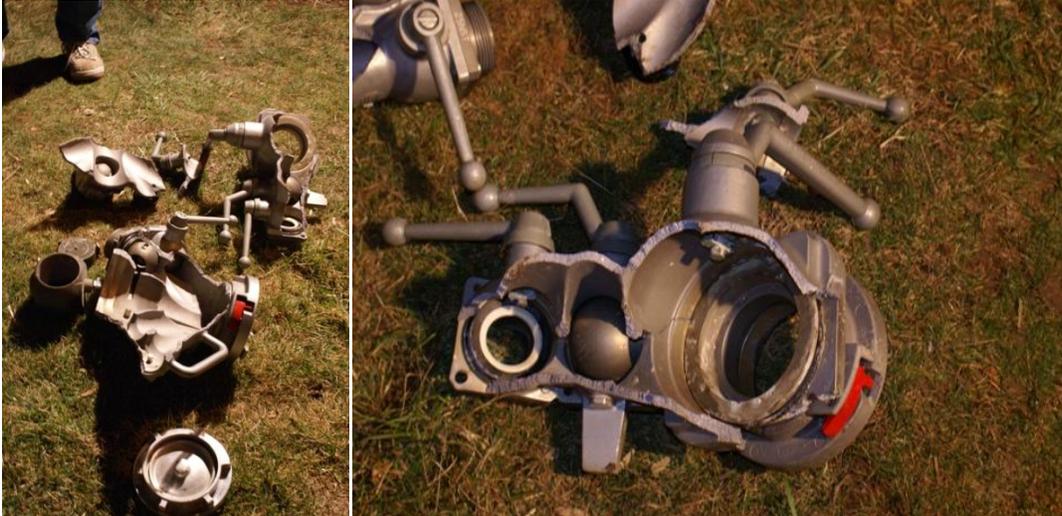
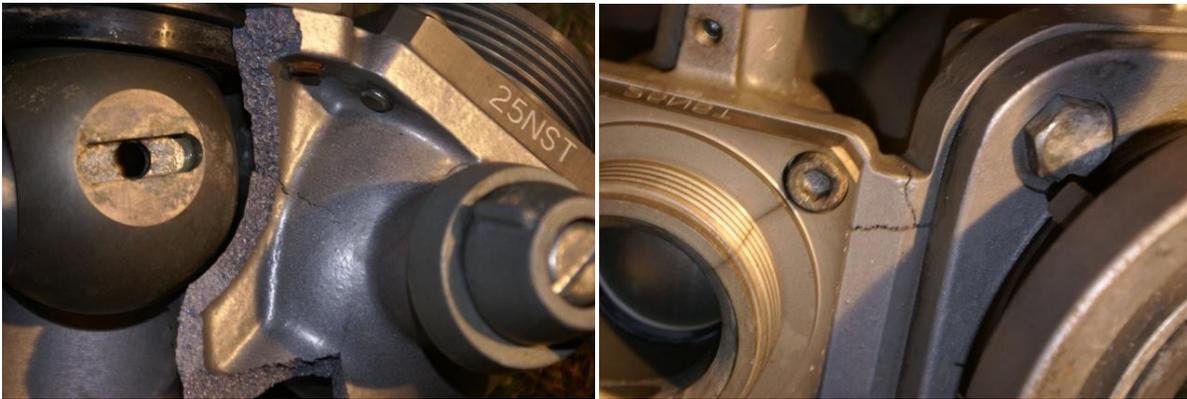
The fire department also submitted several photos of the failed appliance, see following.

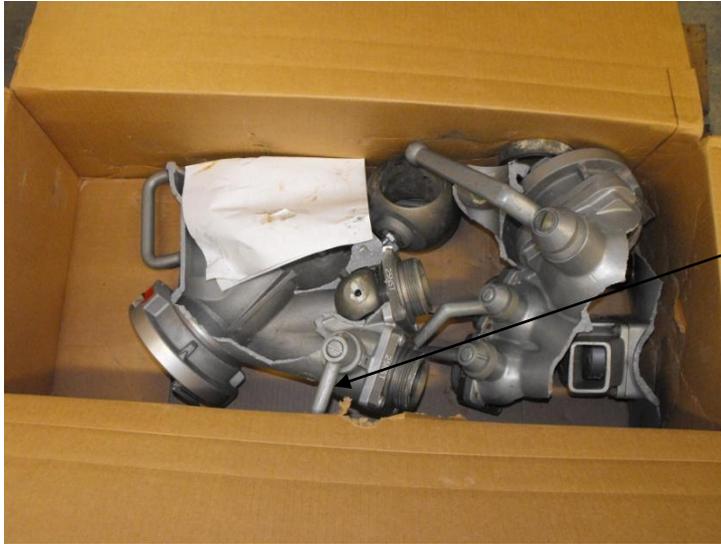
The manifold parts as received except with some packing material removed. Although inconsequential to this investigation, note the handle protruding thru the side of the carton.

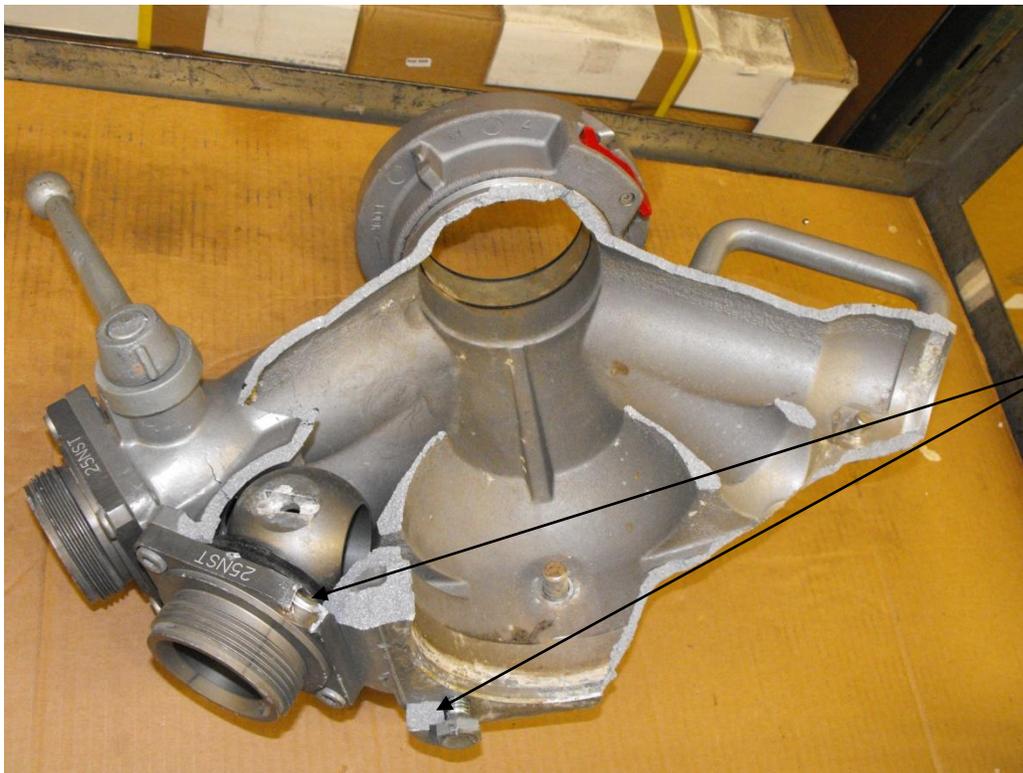
The largest portion of the casting. Note the clean casting at all points along the break. Note failure of two of the connection flanges indicating substantial forces were experienced.

Examination of the casting reveals no casting flaws that would result in a failure of this magnitude. There was also no evidence of corrosion anywhere along the failure line which would indicate the presence of a pre-existing flaw or crack. The manifold casting appears to have been in serviceable condition prior to the failure.

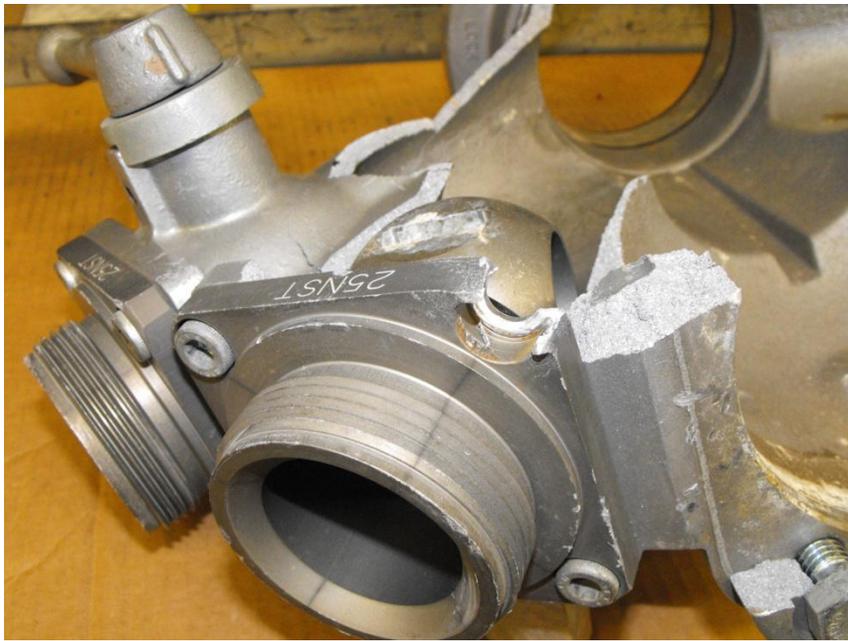
Close-up view of the damaged flange.

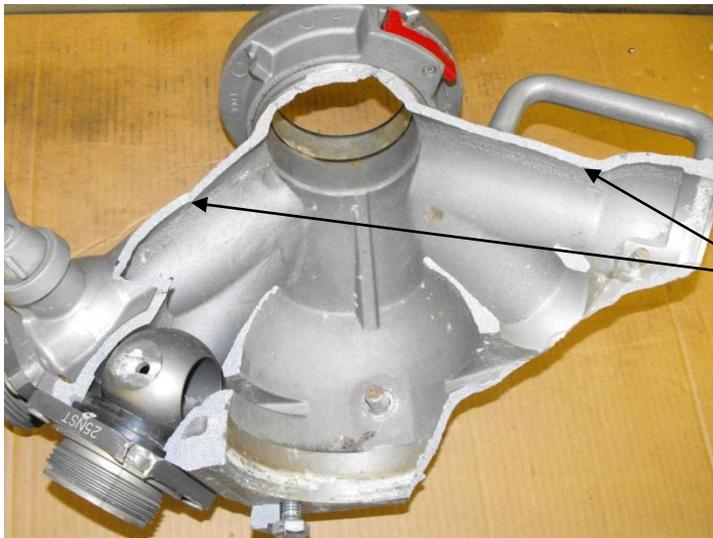
Failure occurred above the casting lines which speaks to the integrity of the casting. A compromised casting would tend to fail within the parting line itself.

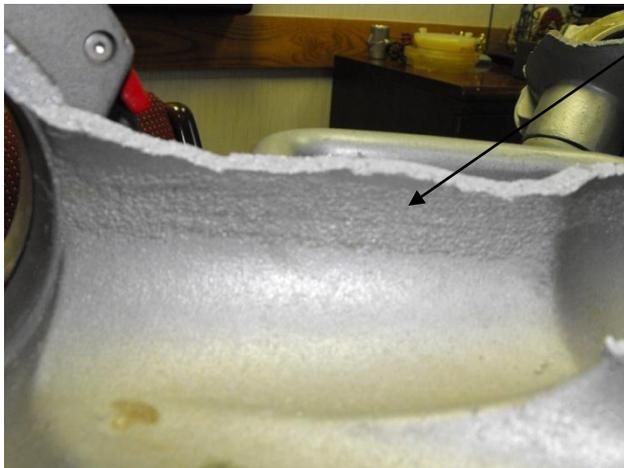
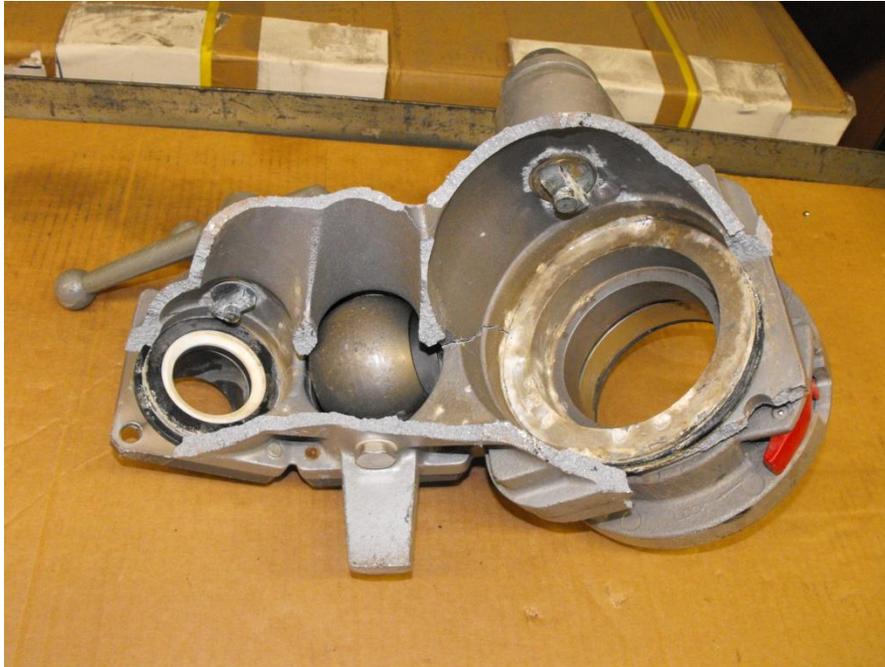
The other major portion of the manifold. Note clean casting along the failure. Also note the broken flange on the Storz adapter, again illustrating that substantial force was applied.

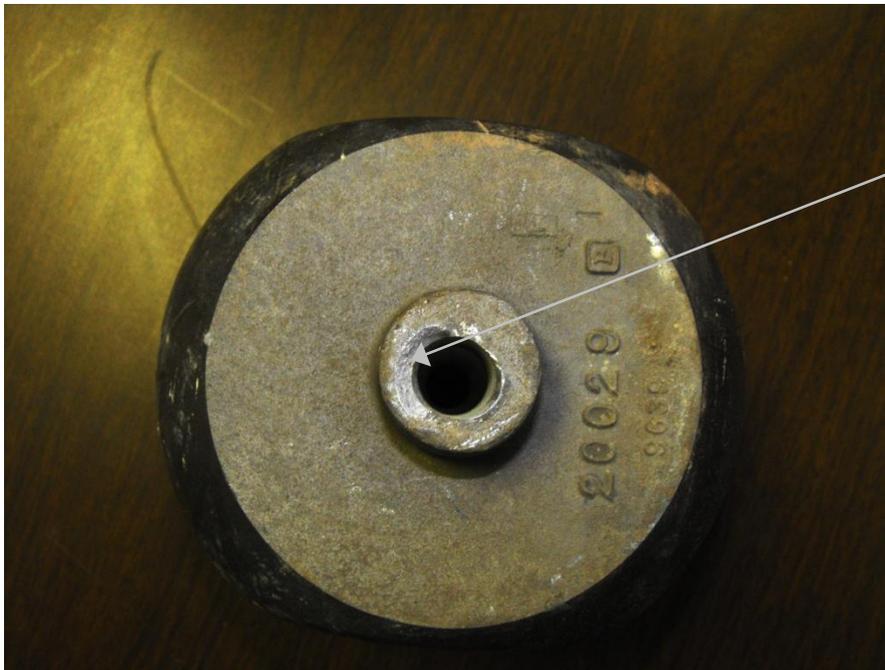
The large ball from the 4 inch port. Note the substantial damage to the pin opening. Part of the casting is broken out of the hole. This is an indication of a substantial pressure being applied to the ball and forcing it out of it's normal position.

An extreme failure such as this can only occur by exposing the manifold to a sudden, significant pressure spike well above the rated burst pressure of the casting. As the attached literature indicates, the manifold is rated to 710 psi burst pressure, therefore the unit experienced a pressure substantially higher than this.

1. Water hammer is an extremely destructive force and must be prevented at all costs.
2. Due to the significant damage caused to this appliance, Snap-tite Hose highly recommends a thorough inspection of other components which may have been subjected to this pressure

spike. This would include other appliances, hoses, connectors, adapters, and perhaps truck piping and pumps.

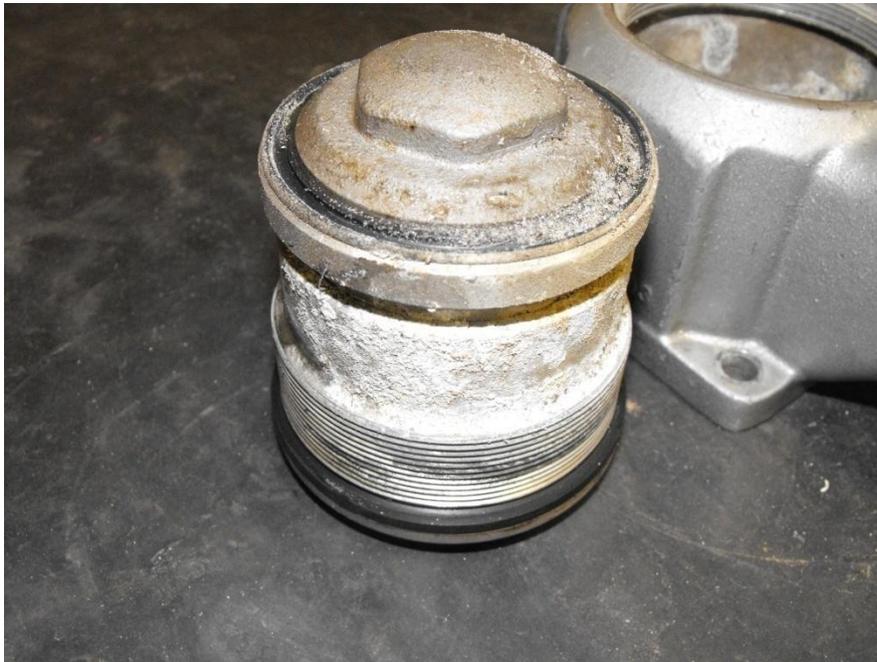
The set screw was then backed out and the valve re-tested. Again, the valve did not open. At this point the valve was disassembled and found to be heavily corroded. The photo below illustrates the relief cartridge with heavy external corrosion. In this photo the springs are intact within the valve and under normal conditions should be able to move the piston out of the bore, but are prevented from doing so by corrosion. The cartridge was subsequently lubricated, then heated, but still could not be taken apart.

It is apparent that the relief valve was not maintained or tested as suggested by NFPA 1962, Chapter 8. Periodic testing of the valve would have detected that it was non-operational.

3. Relief valve maintenance is critical to the safety of personnel and equipment. The guidelines for appliance maintenance and testing as established in NFPA 1962 are highly recommended. We recommend that all relief valves be immediately tested for proper operation, and that a schedule be created and maintained.
4. All appliances should be service tested annually as recommended by NFPA 1962.

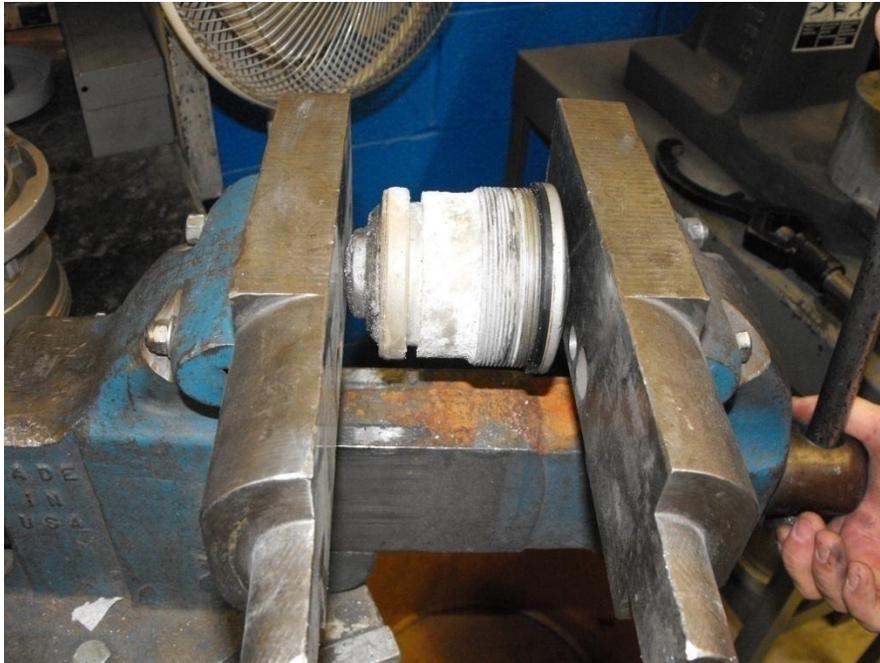
Attempting to compress the relief cartridge in a vise to loosen the corrosion.
