Safety Alert Bulletin

NIOSH report issues floor systems warning after Indiana firefighter death

NIOSH
Fire Fighter Fatality Investigation
and Prevention Program

Volunteer Deputy Fire Chief Dies after Falling Through Floor Hole in Residential Structure during Fire Attack—Indiana

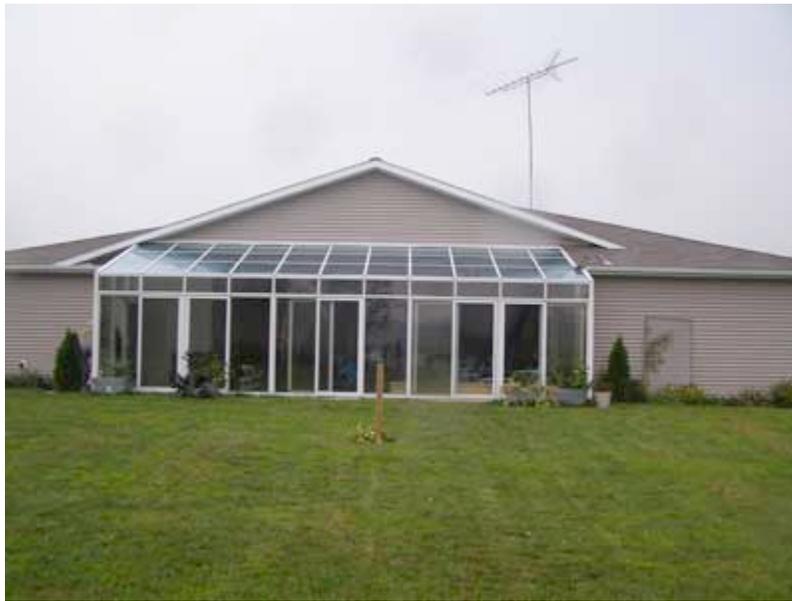
Photo 1: Side-C of the structure. Photo courtesy of the fire department.

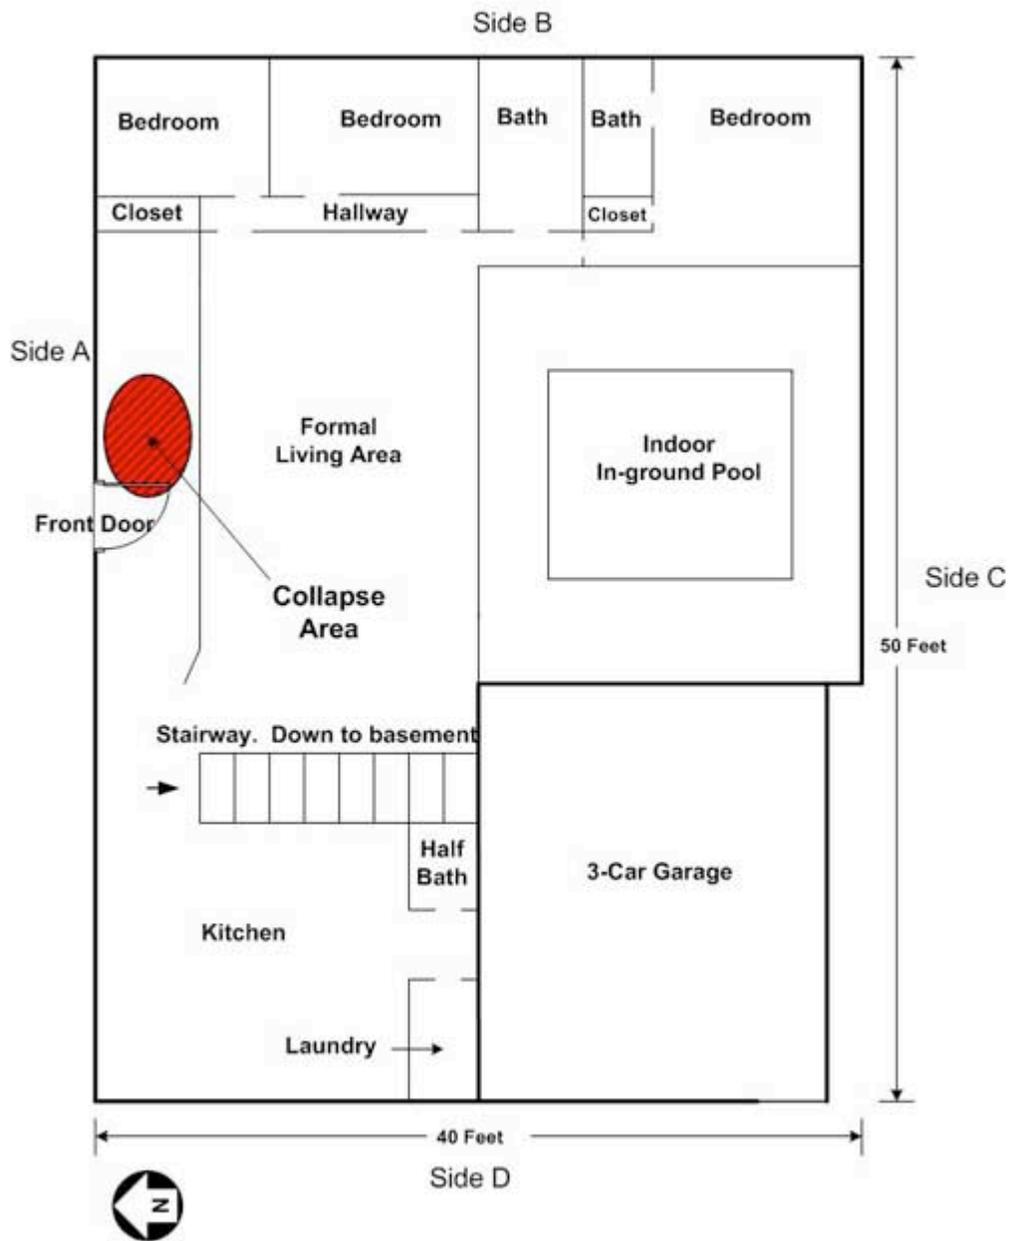
Figure 1. Main Level

The one-story ranch-style residential structure was approximately 2,000 sq. ft. (main floor) in size, and it was built in 2004 of wood-frame construction. There was a partial unfinished basement of approximately 1,200 sq. ft. The exterior was finished with horizontal vinyl siding. The main level flooring system was comprised of pre-engineered I-joists that measured 26' in length x 18" deep, with 3 ½" flanges. The joists were set 19 ½" on center. Two main beams supporting the system were 26' long and consisted of 2" x 12" laminated beams. The floor decking in the area of the hole consisted of ¾" oriented strand board (OSB), covered by ¼" luan and vinyl tile. The structure was heated and cooled via natural gas and electricity. There was a glass-enclosed porch covering an in-ground pool that was attached to Side C of the home ([Photo 1](#) and [Figure 1](#)).

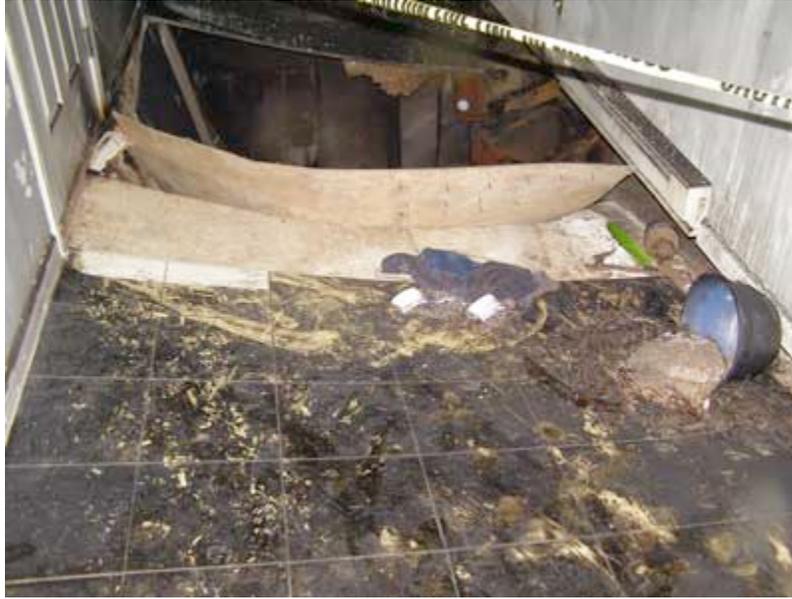
The volunteer Captain who arrived on E-402 (Captain #1) declared initial incident command (IC). The victim and IC conversed briefly and decided to make entry through the front door with a 1 3/4" pre-connected hand line charged by a compressed air foam system (CAFS) for search/rescue and to search for the seat of the fire. *(Note: the pump operator (Captain # 1) noted that they were using 60gpm/60cfm class "A" foam at 125psi).* The IC also served as pump operator. After going on air, the victim and FF#1 (the entry team) entered the structure through the front door (A-side) entrance at approximately 1442 hours, noting that a section of the floor just to the left of the front door had already given way. Once inside to the right approximately 6 feet, the team realized the floor under them was very hot and "spongy." At the same time, the conditions inside the structure became untenable, with intensifying heat and "zero visibility" as a result of thick, black smoke. Within 30-45 seconds of making entry, the victim informed FF#1 that they were going to evacuate to get a light. As they exited the structure, they pulled the hose line out with them. The victim stayed at the front entrance with the nozzle and sent FF#1 to E-402 to retrieve a box light and to pull another pre-connect. *(Note: at this point, team integrity was compromised leaving one fire fighter operating alone in close proximity to the fire.)* After retrieving the light, the victim instructed FF#1 to stretch the additional line around to the B-side to hit the fire in the basement through a window *(Note: the basement window led to a crawl space, so no water actually hit the basement, or the fire).* Also, during this time, FF#2 set up a positive pressure ventilation (PPV) fan at the entrance on side A. The victim stayed at the front entrance (alone a second time) to reportedly attack the fire through the hole in the floor just to the left of the entrance (see [Photo 2](#) and [Figure 2](#)).

Photo 2: Depicts the failed floor from above. Note the front door in the upper left-hand corner. Photo courtesy of the fire department.

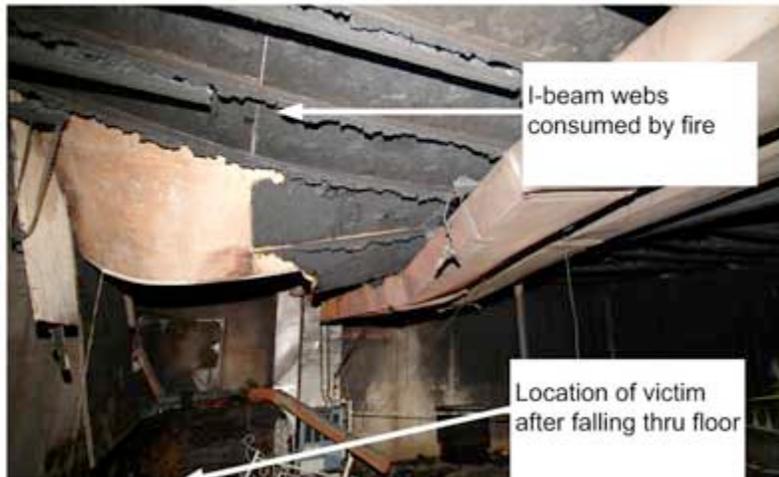
Around this time, the Assistant Chief arrived on scene in E-406, along with one fire fighter, but did not assume IC. As the Assistant Chief made his way to A-side of the structure, he saw a hose going down through a hole in the floor just inside the main entrance (see [Photo 3](#)). He yelled down into the hole and heard a muffled reply. He could not hear what the victim was saying, so he turned down the positive pressure ventilation (PPV) fan and then very clearly heard the victim yell for help (*Note: it was stated by the Assistant Chief that the clarity of the victim's voice indicated that he had apparently taken his SCBA mask off to communicate*). The Assistant Chief immediately called to E-402 for a 14' roof ladder to be placed into the hole in the floor. At this time, FF#1 returned to A-side and started to slide down into the hole (prior to the ladder being placed) to try to retrieve the victim.

Photo 3 illustrates the floor failure area, viewed from the basement. Photo courtesy of the fire department

The basement area to the left of FF#1 (A-B corner in basement) as well as the unfinished ceiling and unprotected floor joists were burning and FF#1 had to use a handline to put water on the fire before descending. As soon as FF#1 reached the lower level, his low-air alarm went off. FF#1 immediately climbed out of the basement and went to replace his air bottle. FF#2 and the Assistant Chief then attempted to position the 14-foot ladder for safe access into the basement, but as a result of debris and clearance inadequacies, the ladder did not reach the lower level. Once the ladder was somewhat in place, the Assistant Chief and FF#2 descended into the basement and immediately found the victim near the hole in the floor. The victim was dragged to the area of the basement stairs. FF#2 stated that when he was with the victim, he shook him, pinched his ear lobe in an attempt to elicit a response, and checked for a pulse (*Note: FF#2 was also an emergency medical technician who reported that the victim was unresponsive, with his mask off at this time*). The homeowner arrived on scene and made the fire department aware that a 900 pound safe was positioned in the area above where the Assistant Chief and FF#2 were working. The safe was on the East wall – near the center of the room and had fallen into the main support of the structure. The Assistant Chief and FF#2 moved the victim from under this area. By this time, T-404 (two fire fighters) and R-405 (one fire fighter) had arrived on scene, as well as several fire fighters via POV. FF#1 returned with a fresh air bottle just as FF#2 ascended the ladder.

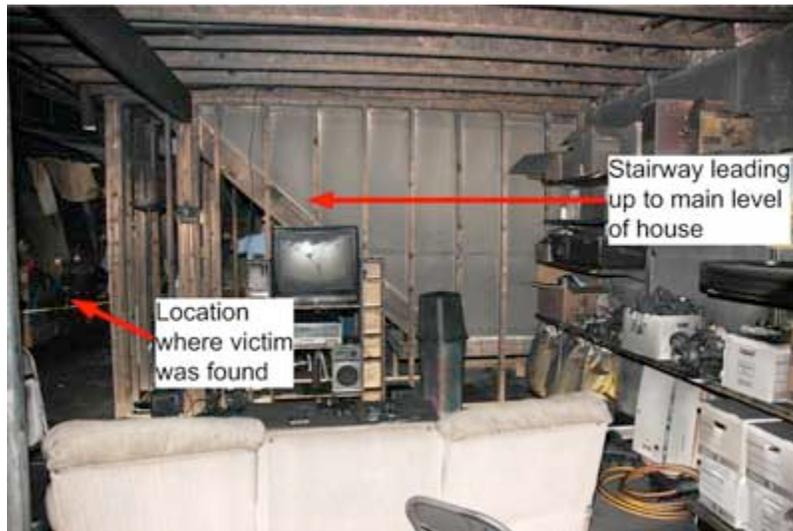
Photo 4: Basement layout showing stairway to main level of house.

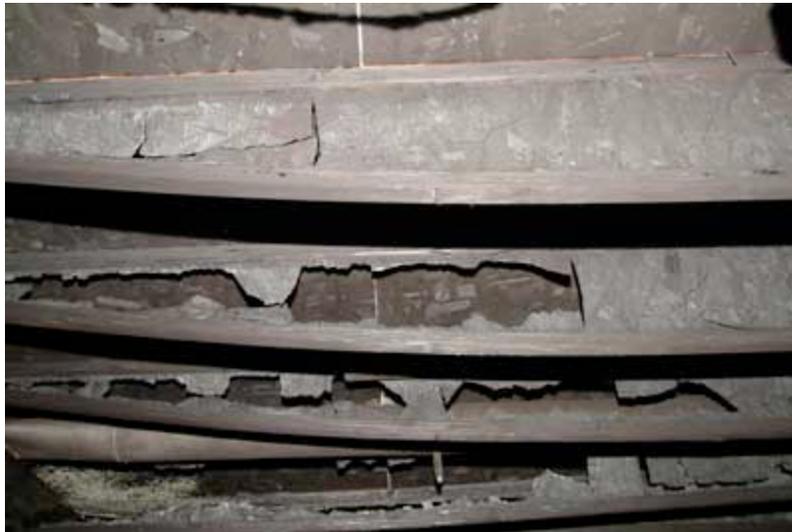
While objective time-to-failure studies of the various lightweight flooring systems being used today have been conducted only in limited cases, evidence from two FFFIPP investigations suggest and seems to support the fact that engineered I-joists quickly lose strength and integrity when damaged and weakened by

heat exposure and flame impingement. ([Photo 5](#)) Often, the weakened I-joists can be difficult to detect from above as the floor surface above may still appear intact. Fire fighters who operate on floors above fire-damaged engineered I-joists may fall through the weakened floor and become trapped in the fire below. Incident commanders and fire fighters should be aware that these members can fail quickly and without warning, and they should plan interior operations accordingly.

Photo 5: Depicts the significant damage suffered by the webbing of the I-joists as compared to the flanges. This damage resulted in floor instability and failure. Photo courtesy of the fire department.

Recommendation #1: Fire departments should ensure that fire fighters and incident commanders are aware that unprotected pre-engineered I-joint floor systems may fail at a faster rate than solid wood joists when exposed to direct fire impingement, and they should plan interior operations accordingly.
