## DOWNED POWER LINES MAY CAUSE OBJECTS TO BE ENERGIZED, POSSIBLY WITH LETHAL RESULTS.

Distributed by the  
NYS Division of Homeland Security and Emergency Services

OFFICE OF  
**FIRE PREVENTION  
& CONTROL**

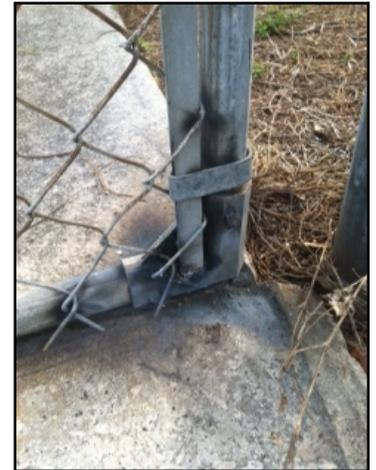
There is no such thing as a “routine” call. The call came in to Miami Dade FD as Fire Out on a chain link fence. Upon arrival it was noted that at various locations on the chain-link, particularly to the posts, there was evidence that serious heat/electrical current had traveled through the fence. Miami Dade firefighters made sure everyone stayed away from the fence, called Florida Power & Light (FPL), and checked the back yards for any live wires possibly coming into contact with the fence. There was no evidence of lines down anywhere. When FPL arrived, through a lengthy investigation they came to the conclusion that the neighbor’s house had a main line going into the house that was frayed and exposed about every foot (shown only by spots of gray wire showing here and there). FPL representatives said that the impulses of electricity from the pole was disintegrating an already weakened line into that neighbor’s house. Once that electricity entered the pipes of the house it searched for anything/anywhere there was a weak or absent ground. That house had a decent ground; however, it found the open or weak ground....in the fence of the house the fire department were dispatched to, over 100 feet away. FPL representatives immediately pulled both meters to the houses. FPL said had anyone touched the fence during the intermittent times the surges were going through they would have been “fried” instantly.

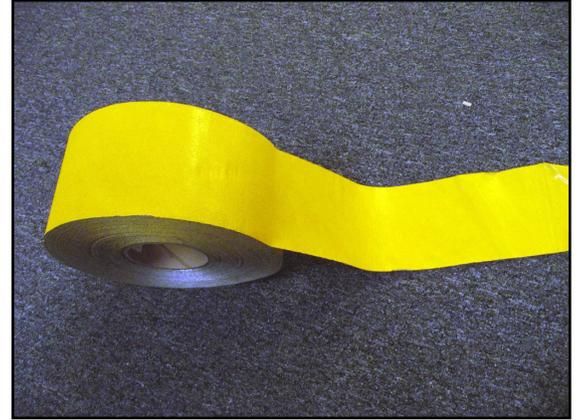
**Hazard Investigation:** After conclusion of the incident, an investigation was done to determine the reason for the electric arc so far away from the downed wire. The downed primary electric wire had fallen and made contact with the double yellow striping in the center of the roadway. Approximately twenty-five (25) feet of the yellow striping had burned and appeared to have melted. Residue from the melted yellow striping exposed what appeared to be the cause of the current flow.

The yellow striping has a metal foil backing running the entire length and width of the stripe. Apparently the downed power line energized the yellow striping and the electric current traveled along the metal foil backing, at least the distance of the crack in the roadway and continued for an undetermined distance. When the current reached the crack in the stripe and the roadway, the current jumped across the opening causing the arcing condition that was observed. It is unknown if the rain conditions increased the ability of the yellow striping to conduct electricity.

**Precautions:** The seriousness of this safety hazard to fire, police, and emergency medical response personnel, utility workers, victims and pedestrians is readily apparent. This condition could potentially be present wherever downed power lines have occurred; such as at auto accidents, wind, rain, snow, and ice storms, electrical equipment overloads or failure, building collapses etc. All emergency response personnel should exercise care to avoid this hazard. Warnings must be issued to everyone working at the incident scene and entry anywhere near the hazard area must be denied. Incident Safety Officers must assess the injury potential and provide information back to the Incident Commander. Appropriate scene security and safety measures must be accomplished. Fire Chiefs and/or Safety Officers should contact their local DPW or Highway Maintenance Department to determine if this type of “foil-backed” striping is used within your response area.
