## AREA OF ORIGIN TIP: CFL BULB

*Story provided by Bill Schumm at FireGeezer.com*

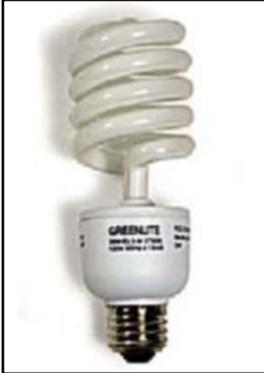
We began the process of checking each bulb and found one in a ceiling fixture that had a ballast failure much like we are accustomed to finding in traditional overhead tube lighting fixtures in commercial buildings.

A CFL bulb contains a ballast at the base of the unit between the spiral tube and (Edison) screw. This ballast, encased in a plastic shell, may or may not have visible vent holes or slots.

The ballast contains a Voltage Dependent Resistor that, when failure occurs, opens like a fuse to protect the device and associated electrical equipment. The resultant heat and smoke should escape from the vents in the housing. Light smoke may be visible and one will smell that distinct electrical ballast odor. As in the case the other night, there were visible smoke marks and a small, brown oily/goosey residue at the vent holes. These signs were not visible with the bulb in its socket.

Since more CFL bulbs are finding their way into the home, don't overlook these items when investigating a smoke odor.

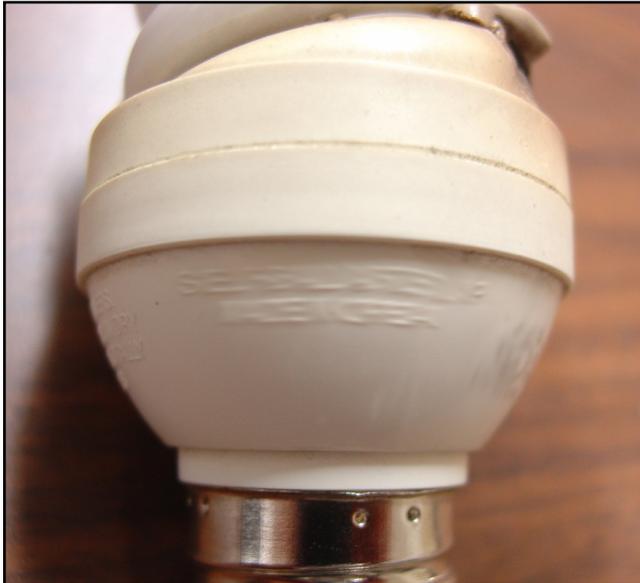
Dave Statter (STATter911.com) sent this photo of one of these lightbulbs that had a similar problem. You can see that in this instance the discoloration and charring is visible on the outside.
