Fire Fighter Fatality Investigation and Prevention Program

May 08, 2008

Improper Set-up of Aerial Ladders with a Locking Waterway May Put Fire Fighters at Risk

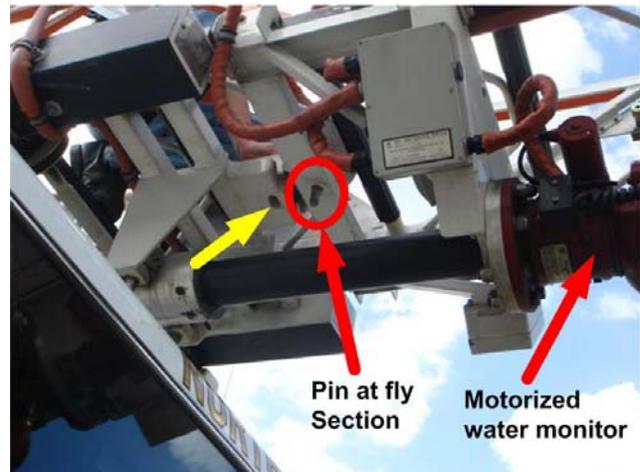
Photo 1 - A properly seated pin at the fly section for defensive water stream operations is highlighted in the red circle. The hole behind it (yellow arrow) shows the location where the pin would be inserted (from the top) to keep the monitor assembly back at the second ladder section for rescue mode. **NOTE:** Various methods are used throughout the fire apparatus industry to secure the waterway: this picture represents a pin-anchored waterway design.

- **Ensure that Standard Operating Procedures (SOPs) and/or Guidelines (SOGs) on setting up multi-position waterways include steps to properly position the waterway and to inspect and verify that the locking mechanism (anchoring pin(s), lever, clamps, etc.) are properly installed and functioning as designed before pressurizing the waterway.**
- **Properly train and practice the correct method of securing waterways and verifying they are secured (per manufacturer's recommendations).**

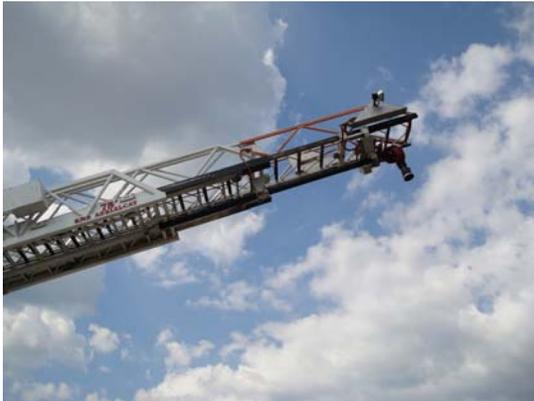
Photo 2 – Aerial ladder with monitor at tip

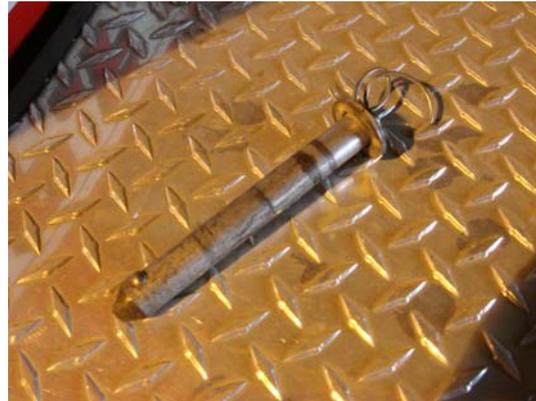
Photo 3 – anchoring pin

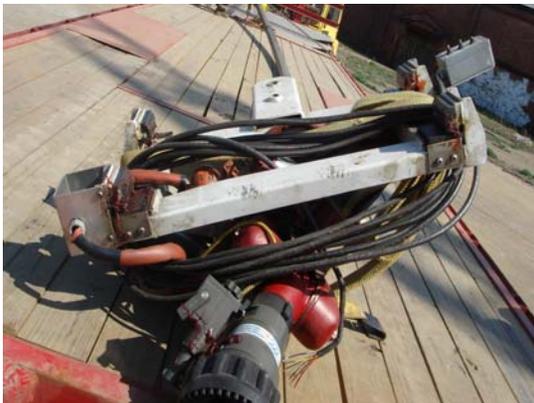
On April 8, 2008, a volunteer Deputy Fire Chief (the Incident Commander), was killed when struck by a motorized water monitor and 30 feet of aluminum pipe that was “launched” off an elevated aerial ladder at a fire at an industrial manufacturing plant in Pennsylvania. The truck was normally transported in the “rescue mode” with the monitor pinned to the second section of ladder so that the waterway would not be in the way if the ladder was set up for rescue operations. At the incident scene, when the waterway was pressurized, the monitor and its support bracket, along with the last 30-foot section of pipe were “launched” off the aerial ladder by the force of the water pressure in the pipe. The monitor flew approximately 75 feet and fell, striking the Incident Commander on the head, killing him instantly. After the incident, the anchor pin was found on the ground, in front of the truck’s cab. The waterway did not include any secondary mechanical stops to prevent the separation of the water monitor in the event the anchoring pin was not properly seated. The NIOSH Fire Fighter Fatality Investigation and Prevention Program is currently investigating this incident and a full report will be available at a later date.

Photo 4 – Monitor and pipe that “launched”

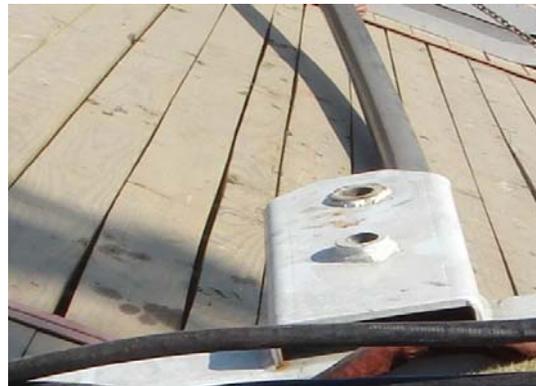
Photo 5 - The receiver assembly where the pin is inserted
