Safety Alert Bulletin

NIOSH report issues floor systems warning after Indiana firefighter death

NIOSH
Fire Fighter Fatality Investigation
and Prevention Program

Volunteer Deputy Fire Chief Dies after Falling Through Floor Hole in Residential Structure during Fire Attack—Indiana

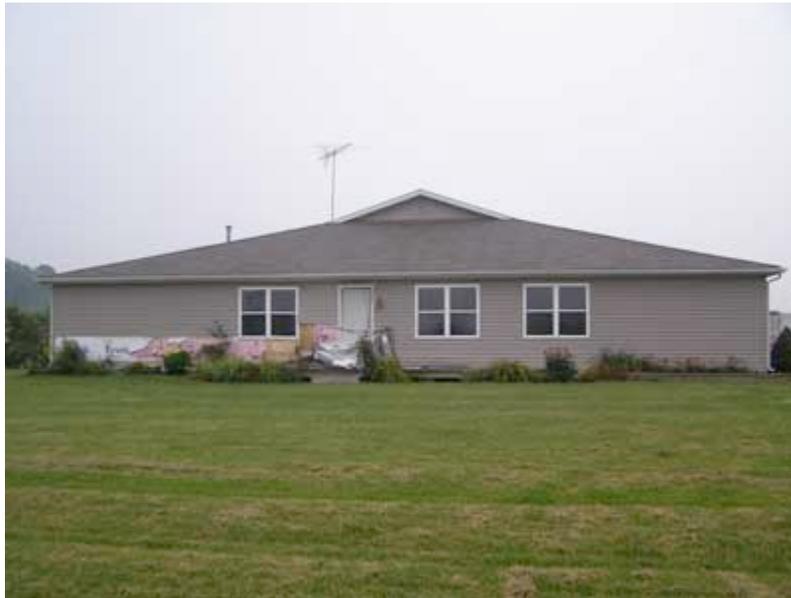
The volunteer Captain who arrived on E-402 (Captain #1) declared initial incident command (IC). The victim and IC conversed briefly and decided to make entry through the front door with a 1 3/4" pre-connected hand line charged by a compressed air foam system (CAFS) for search/rescue and to search for the seat of the fire. *(Note: the pump operator (Captain # 1) noted that they were using 60gpm/60cfm class "A" foam at 125psi).* The IC also served as pump operator. After going on air, the victim and FF#1 (the entry team) entered the structure through the front door (A-side) entrance at approximately 1442 hours, noting that a section of the floor just to the left of the front door had already given way. Once inside to the right approximately 6 feet, the team realized the floor under them was very hot and "spongy." At the same time, the conditions inside the structure became untenable, with intensifying heat and "zero visibility" as a result of thick, black smoke. Within 30-45 seconds of making entry, the victim informed FF#1 that they were going to evacuate to get a light. As they exited the structure, they pulled the hose line out with them. The victim stayed at the front entrance with the nozzle and sent FF#1 to E-402 to retrieve a box light and to pull another pre-connect. *(Note: at this point, team integrity was compromised leaving one fire fighter operating alone in close proximity to the fire.)* After retrieving the light, the victim instructed FF#1 to stretch the additional line around to the B-side to hit the fire in the basement through a window *(Note: the basement window led to a crawl space, so no water actually hit the basement, or the fire).* Also, during this time, FF#2 set up a positive pressure ventilation (PPV) fan at the entrance on side A. The victim stayed at the front entrance (alone a second time) to reportedly attack the fire through the hole in the floor just to the left of the entrance (see [Photo 2](#) and [Figure 2](#)).

Photo 2: Depicts the failed floor from above. Note the front door in the upper left-hand corner. Photo courtesy of the fire department.
