## DOWNED POWER LINES MAY CAUSE OBJECTS TO BE ENERGIZED, POSSIBLY WITH LETHAL RESULTS.

Distributed by the  
NYS Division of Homeland Security and Emergency Services

OFFICE OF  
**FIRE PREVENTION  
& CONTROL**

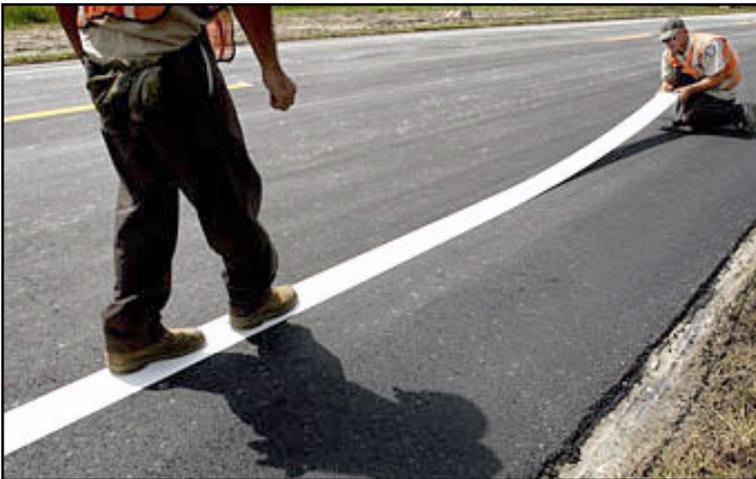
**Hazard Investigation:** After conclusion of the incident, an investigation was done to determine the reason for the electric arc so far away from the downed wire. The downed primary electric wire had fallen and made contact with the double yellow striping in the center of the roadway. Approximately twenty-five (25) feet of the yellow striping had burned and appeared to have melted. Residue from the melted yellow striping exposed what appeared to be the cause of the current flow.

The yellow striping has a metal foil backing running the entire length and width of the stripe. Apparently the downed power line energized the yellow striping and the electric current traveled along the metal foil backing, at least the distance of the crack in the roadway and continued for an undetermined distance. When the current reached the crack in the stripe and the roadway, the current jumped across the opening causing the arcing condition that was observed. It is unknown if the rain conditions increased the ability of the yellow striping to conduct electricity.

**Precautions:** The seriousness of this safety hazard to fire, police, and emergency medical response personnel, utility workers, victims and pedestrians is readily apparent. This condition could potentially be present wherever downed power lines have occurred; such as at auto accidents, wind, rain, snow, and ice storms, electrical equipment overloads or failure, building collapses etc. All emergency response personnel should exercise care to avoid this hazard. Warnings must be issued to everyone working at the incident scene and entry anywhere near the hazard area must be denied. Incident Safety Officers must assess the injury potential and provide information back to the Incident Commander. Appropriate scene security and safety measures must be accomplished. Fire Chiefs and/or Safety Officers should contact their local DPW or Highway Maintenance Department to determine if this type of “foil-backed” striping is used within your response area.
