## ELECTRICAL FIRES IN COMMERCIAL VEHICLES “SNOW PLOW TRUCKS”

**OFFICE OF  
FIRE PREVENTION  
& CONTROL**

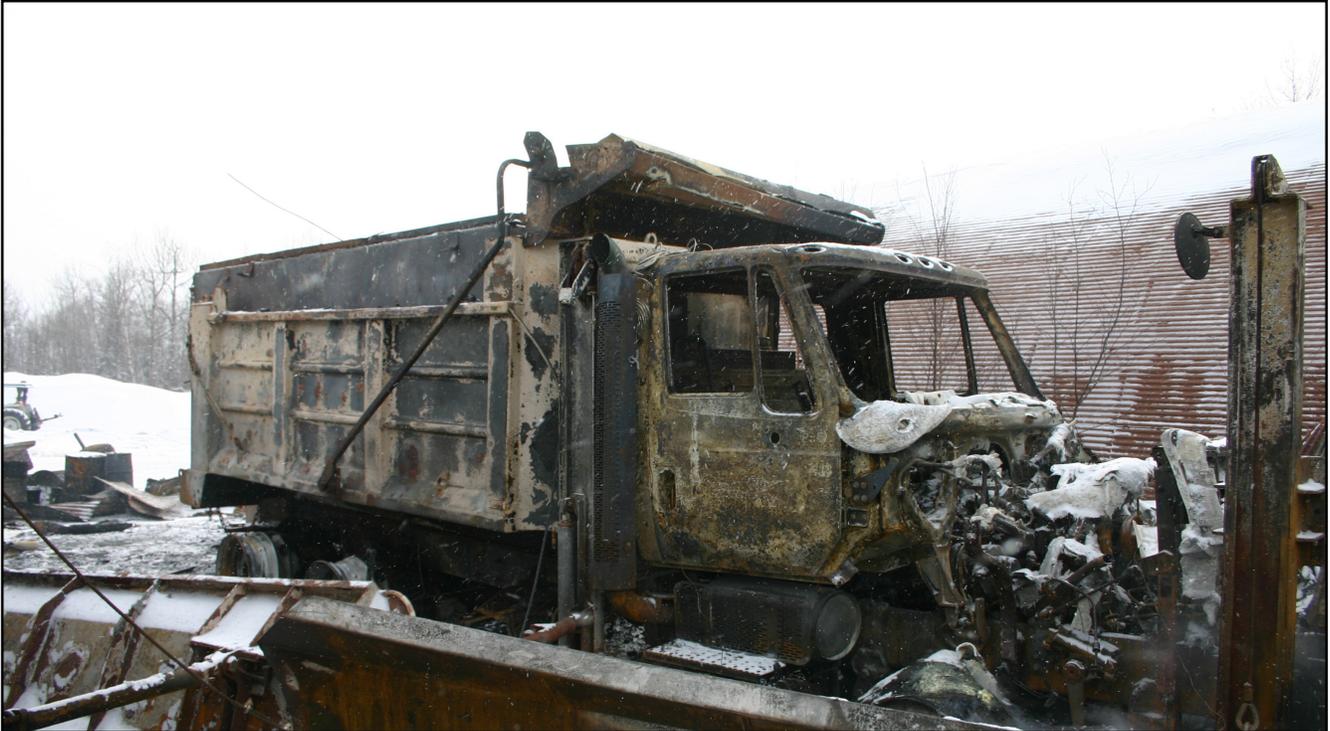
*The destruction pictured illustrates the damage caused by such incident in a facility without early warning detection.*

5. **Inspect** fuel and hydraulic lines for signs of wear and repair and secure as necessary to prevent abrasion.
6. **Protect your facility** by ensuring the building complex is free of common fire hazards and that suitable fire prevention measures are in place and working, to include an effective early fire detection alarm system.

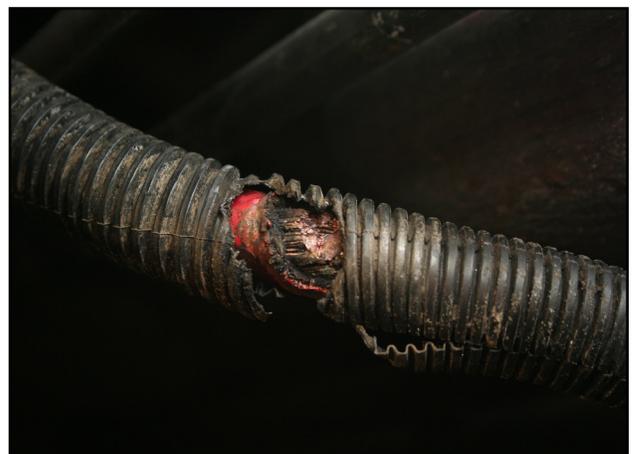
Photo A

**Common Fault** - The cause of these recent fires appears related to the electrical systems of these large commercial vehicles. Fire Investigation revealed electrical short circuiting as a result of worn electrical cable insulation as shown in photo A.

These failures appear to occur where large capacity electrical cables interact or come in contact with the chassis frame or short to ground. Additional electrical equipment problems have been discovered attributable to missing or improper fusing of installed equipment.

1. **Inspect** battery cables and vehicle electrical distribution wiring for signs of wear, chaffing or contact with the frame and secure as necessary to prevent abrasion as illustrated in photo B.
